Ruins Stabilization in the Southwestern United States

RUINS STABILIZATION IN THE SOUTHWESTERN UNITED STATES

**ROLAND VON S. RICHERT and
R. GORDON VIVIAN**

National Park Service
U. S. Department of the Interior
Washington 1974

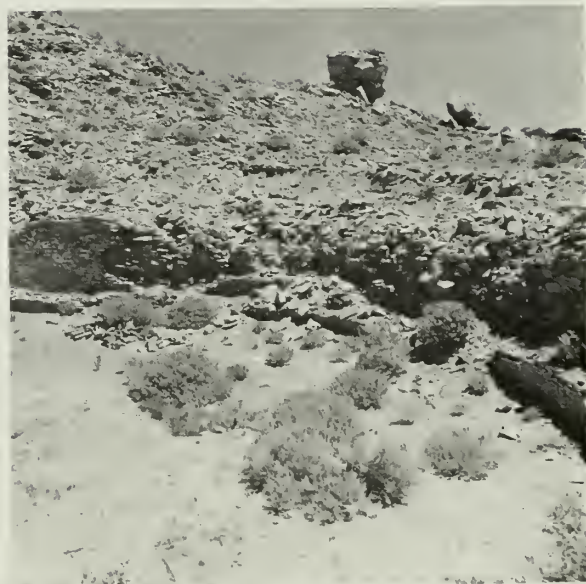
Regardless of the condition in which standing walls are found, it must be remembered that the entire depth of the wall is seldom exposed, and that the exposed portions—which form a base over which the stabilization is being done—have been subject to nearly all the forces listed above, i.e., surface weathering, construction over loose fill or partial walls, breakdown or theft of wood members, erosion at the base, buckling from pressure, excavation, and backfill (fig. 5).

FIGURE 5. Clearing of depressed areas leaves them open to surface runoff and rapid destruction. (The Great Kiva, Kin Nahasbas Ruin, Chaco Canyon National Monument, N. M.)

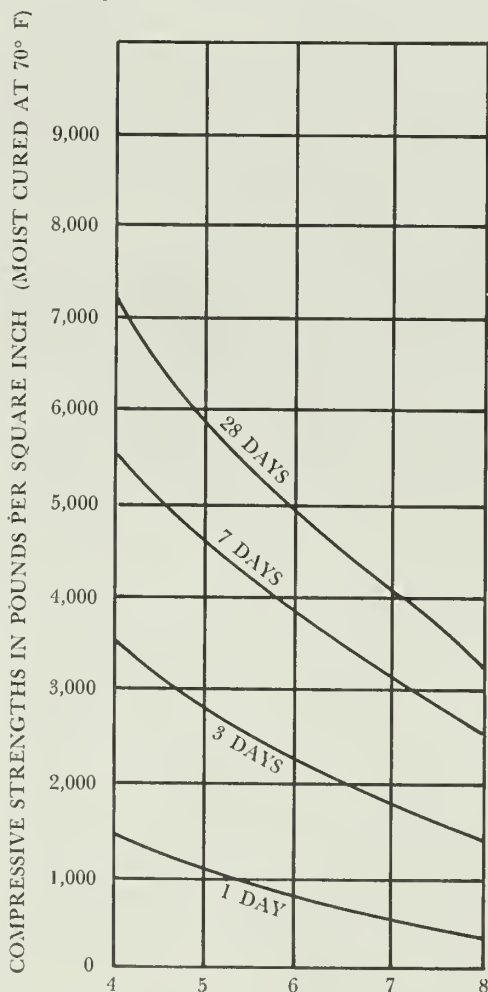
GALLONS OF WATER PER SACK OF CEMENT
FIGURE 6. Strength curves for selected water-cement proportions. Data taken from Portland Cement Association publication entitled *Design and Control of Cement Mixtures*.

The strength of concrete or cement mortar is affected by a number of factors. Among these are the ratio of aggregate-to-cement, ratio of water-to-cement, length of mixing, gradation of the aggregate, and length of moist-curing. Of all these factors, the ratio of water-to-cement is most important. Few supervisors and workmen seem to realize this. Strength curves for various water-cement proportions should be examined (fig. 6) as they show the rapid loss of strength as the ratio of water to cement increases.

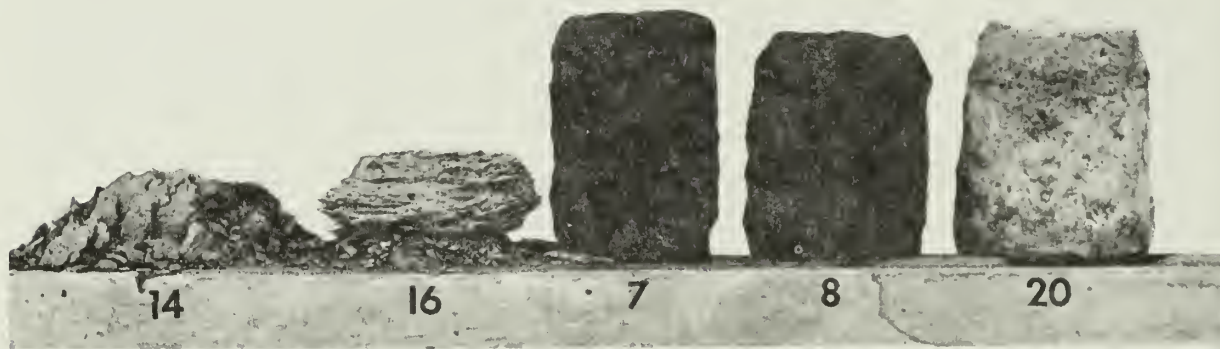
The same kind of cylinders, cured the same length of time, were used in the freeze-thaw test (fig. 7). After curing, the soil-cement cylinders were placed on absorptive pads which extended into a pan of water. Thus, the soil-cement had a constant supply of moisture and there was no limit to the amount available for absorption. Soil-cement and portland will absorb large quantities of moisture (up to 20 percent) and it is useless to try a freeze-thaw test without making moisture available.

3. Cement in the amount of at least 14 percent for cylinder samples was required to resist the action of repeated freezing and thawing. Cylinders at cement content less than 14 percent disintegrated at the third cycle. Observation of the cylinders undergoing tests indicates that no amount of cement will prevent the soil-cement from absorbing moisture either under freeze-thaw or wet-dry conditions. Cement strength must be high enough to resist the force of freezing after the moisture has entered the specimen. Moisture rise in a cylinder 4 inches high was 2 to 3 inches. When cylinders failed under freezing, there was no gradual wearing away of the exterior, but rather a breaking up of the entire area that had absorbed moisture.

FIGURE 7. Selected cylinders subjected to freeze-thaw test. Nos. 14 and 16, with 10 and 12 percent cement by volume respectively, failed at the third cycle. Both were made up with equal parts clay and silt-loam. No. 20, with 15 percent cement by volume, is shown at the 12th cycle. Nos. 7 and 8, consisting of three parts clay, two parts silt-loam, and emulsified bitumen, were tested in conjunction with the soil-cement and are shown at the 15th cycle.

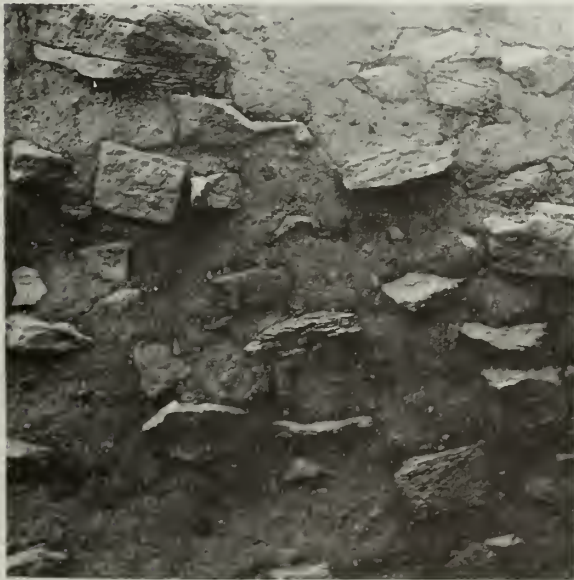
FIGURE 8. The use of heavy grouting to replace native soil between random stone; after 10 years exposure to the elements. (West Ruin, Aztec Ruins National Monument, N. M.)

cations where large amounts of mortar must be left exposed; these include heavy grouting of exposed longitudinal sections where facing is not replaced (figs. 8 and 9).

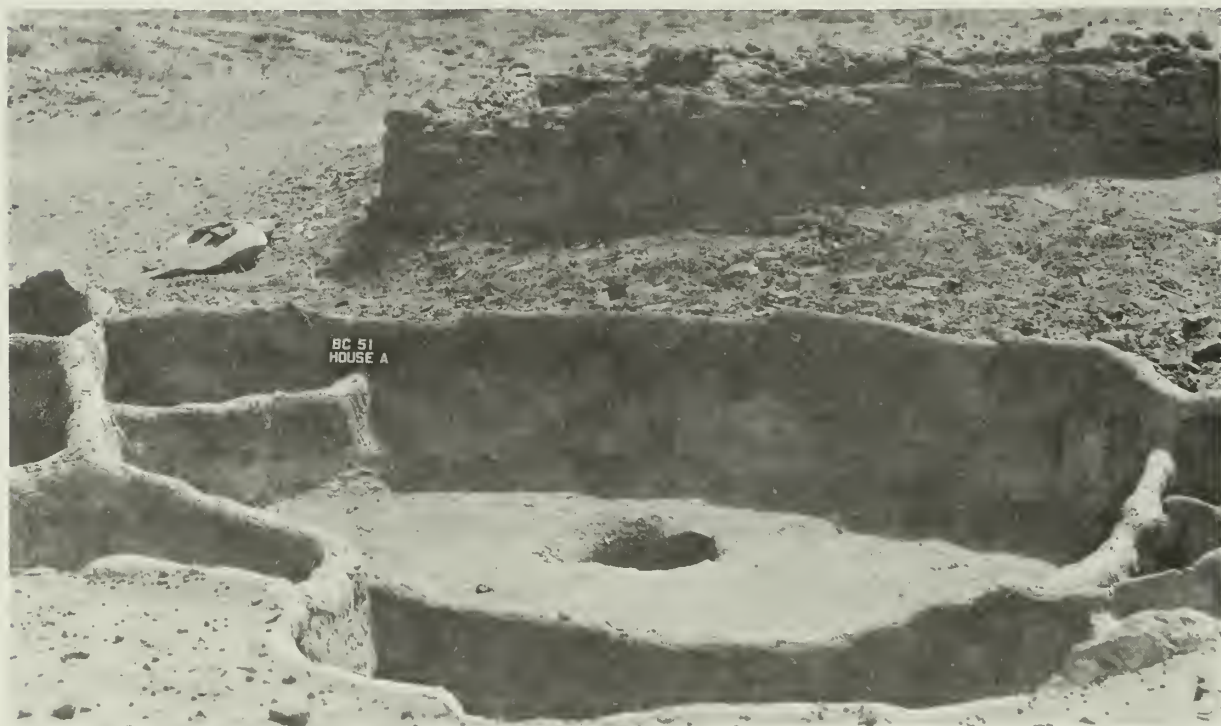
FIGURE 9. Soil-cement in heavy cross section; shown here for the repair of slab-house walls. (Basket Maker III pithouse, Site Bc-51, Chaco Canyon National Monument, N. M.)

The prehistoric wall was dampened and the mix placed between it and the form (fig. 53) well tamped in place to fill undercut spots. It was placed at a depth sufficient to cover the rise of the wall face and was then sloped to conform to the irregular, sloping surface of the wall top. After curing, the forms were removed and when completely dry the entire surface was treated with silicone water repellent (fig. 54). This use of heavier, self-supporting coverings of native materials parallels the already proven use of heavy sections of soil-cement in the repair of pit houses and for making facings in cuts in soft fill (figs. 9 and 10).

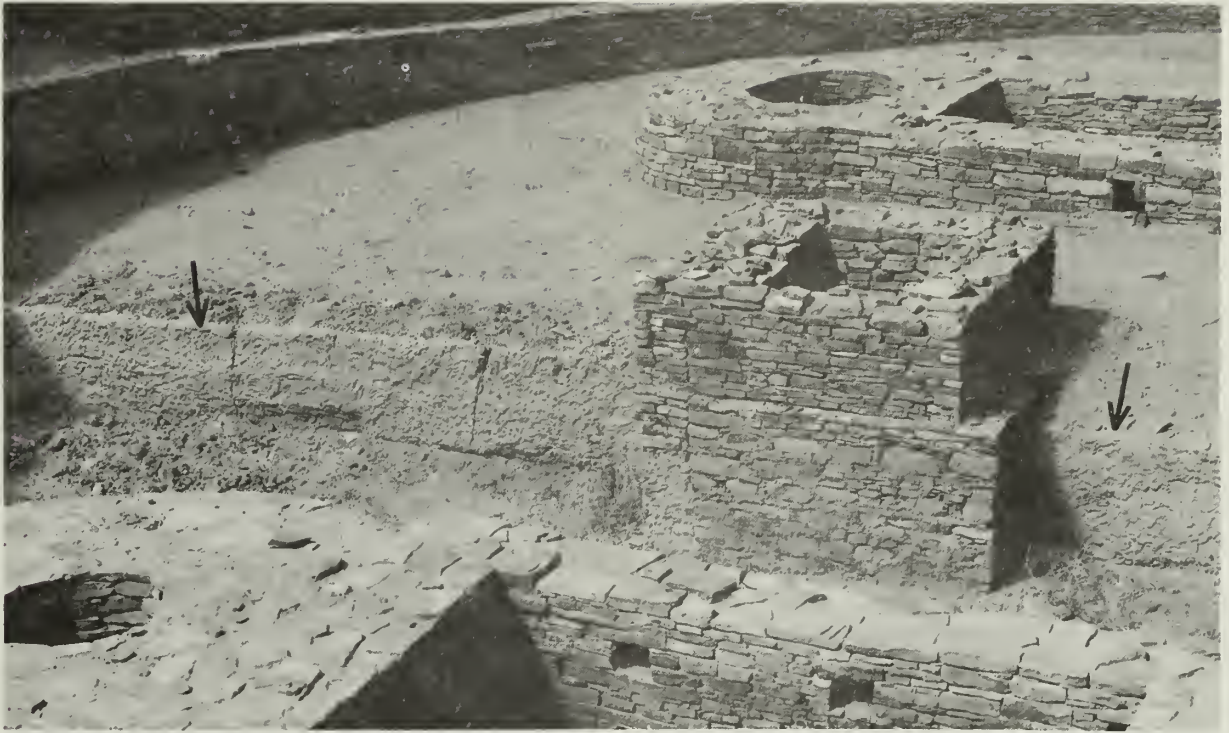
FIGURE 10. Formed soil-cement in retaining sections of fill which must be stabilized to show portions of structures on varying levels. (Great Kiva in the plaza of Chetro Kettle Ruin, Chaco Canyon National Monument, N. M.)

Soil-cement is particularly suited to large repair sections in monolithic soil structures, and is also valuable in stabilizing the sides or ends of cuts in excavations which must be left open for interpretive purposes (fig. 10).

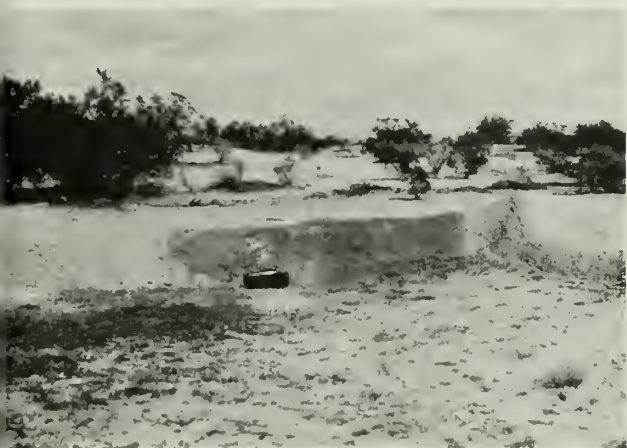
FIGURE 13. West wall of Compound A immediately after a rain. The light areas treated with silicone repelled water. The darker areas were untreated and absorbed moisture rapidly. (Casa Grande Ruins National Monument, Ariz.)

To date, applications of silicone water repellents have been made on the following structures: south wall of the "Big House" at Casa Grande and numerous walls in Compound A (figs. 13, 14) which had been previously covered with a soil-cement coating, and heavy soil-cement sections in Compound B. At Tumacacori the entire granary was treated and an application was made on the patched upper surface of the barrel-vault roof on the sacristy.

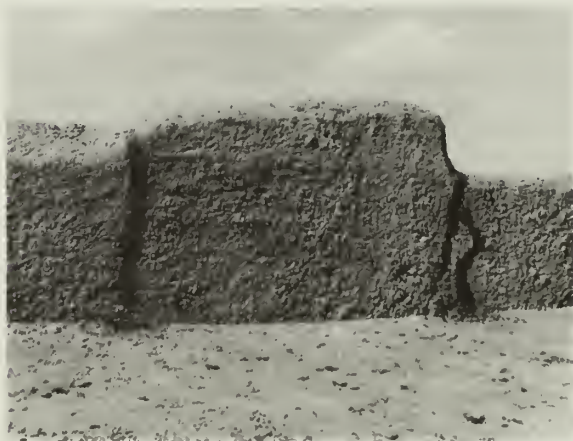
FIGURE 14. West wall of Compound A one year after the application of silicone waterproofing. Two hairline cracks were filled. The untreated smears of plaster have absorbed moisture, while the treated wall remains dry. (Casa Grande Ruins National Monument, Ariz.)

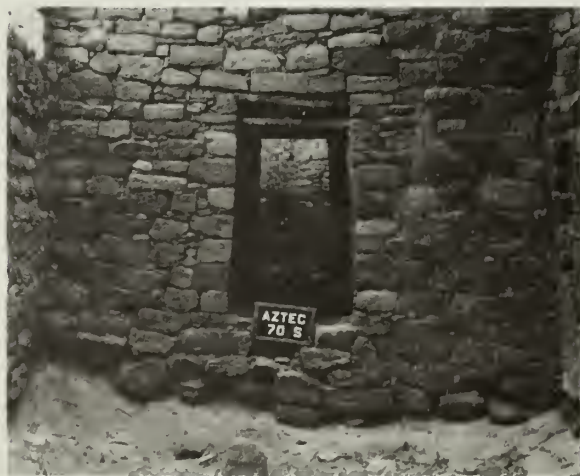
A similar evaluation was made of 19 walls (not retaining fill) constructed of and repaired with the same class of soft stone as in the 21 tested which retained fill. Fifteen remained in good condition. Four showed large wet areas where failure of drainage lines had impounded water (figs. 17 and 18).

FIGURE 17. Basal erosion from capillary moisture is particularly damaging in the interiors of excavated sites where drainage is poor. (West Ruin, Aztec Ruins National Monument, Ariz.)

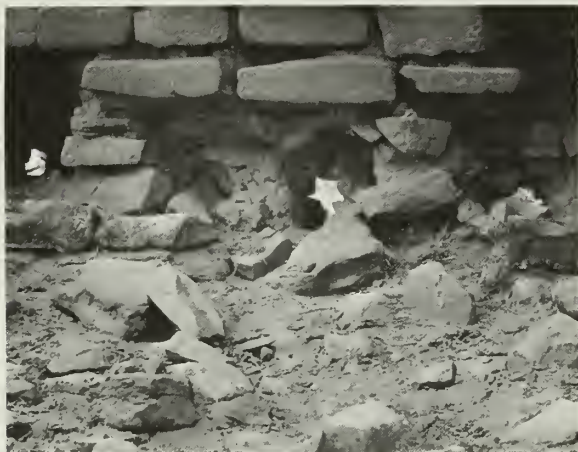
FIGURE 18. The severe undermining and basal erosion of a wall resulting from capillary moisture. If left untreated, such walls soon collapse. (West Ruin, Aztec Ruins National Monument, N. M.)

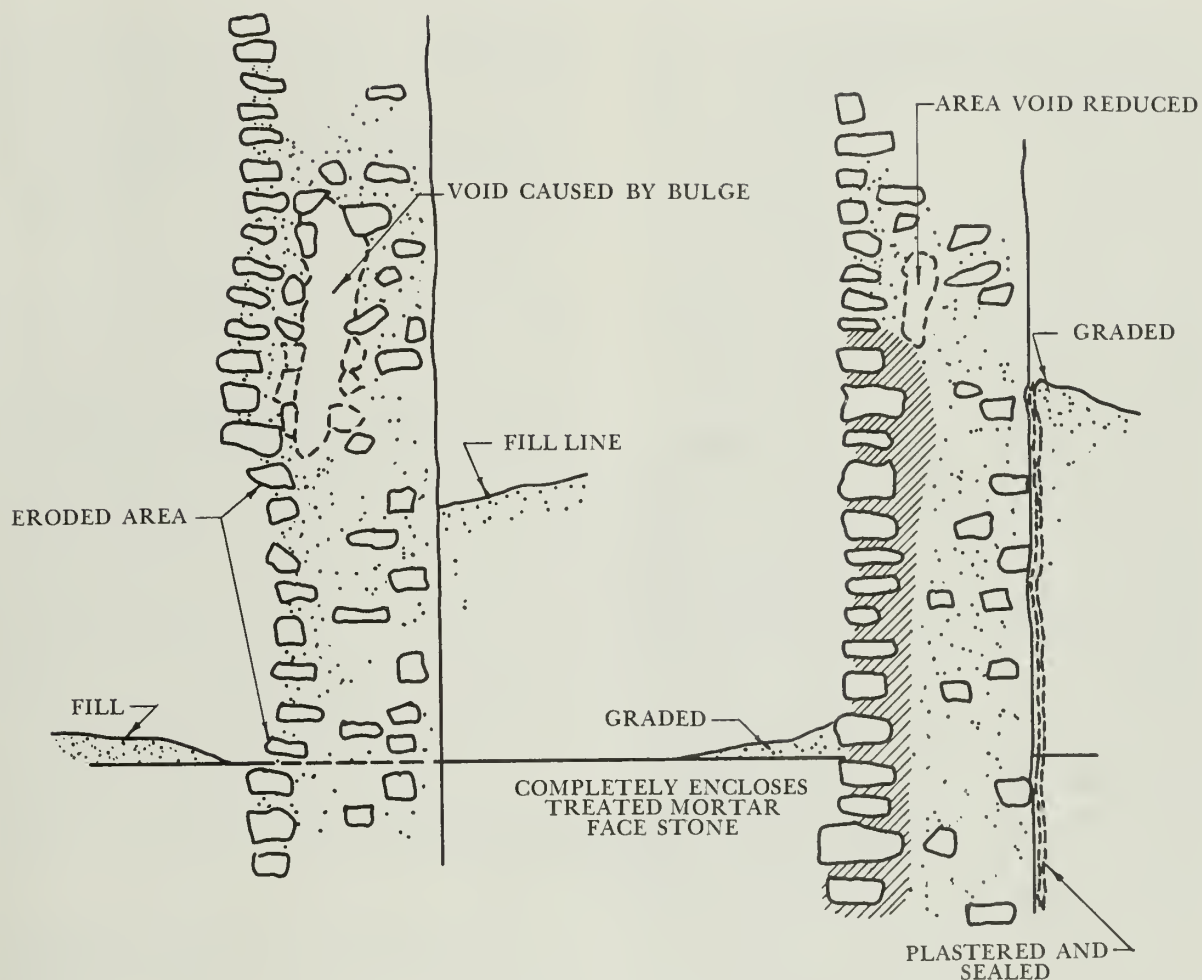
FIGURE 19. Field control of moisture erosion. Wall depicted in section at left before treatment; following stabilization at right.

In laying out stabilization for a wall deteriorating from moisture erosion, consideration must be given to any proposed changes in the fill level (fig. 19). Where the eroded wall also retains fill, the treated mortar should extend somewhat higher than the eroded area to insure against possible increases in the capillary rise. Thus, it is better to include too much rather than too little mortar in the area stabilized. While this might violate the precept of keeping the replacement of prehistoric or original material at a minimum, it is desirable that the replacement be made all at one time rather than over a period of years, as moisture works its way around too small a patch.

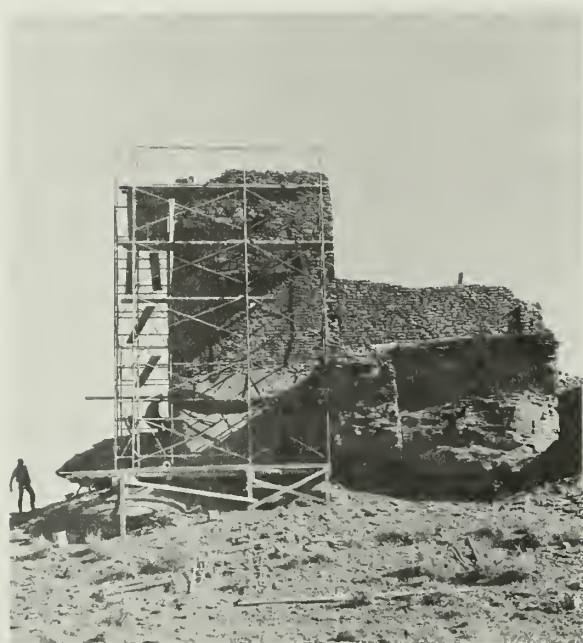
FIGURE 27. Scaffolding in place at completion of respalling and grouting large wall surfaces. (Wukoki Ruin, Wupatki National Monument, Ariz.)

Where masonry walls containing a large proportion of spalls or chinking on the surface are subject to extreme weathering in exposed locations, surface repair may become a time-consuming project. As the spalling is lost to weathering, the soil mortar between individual stones is then exposed. It weathers far more rapidly than did the spalling, and decay of the wall is accelerated. Loose and softened soil mortar must be scraped from between the individual stones, the space then partially filled with cement mortar and the spalls tapped into place in the mortar. Large walls require considerable equipment and an experienced crew (fig. 27).

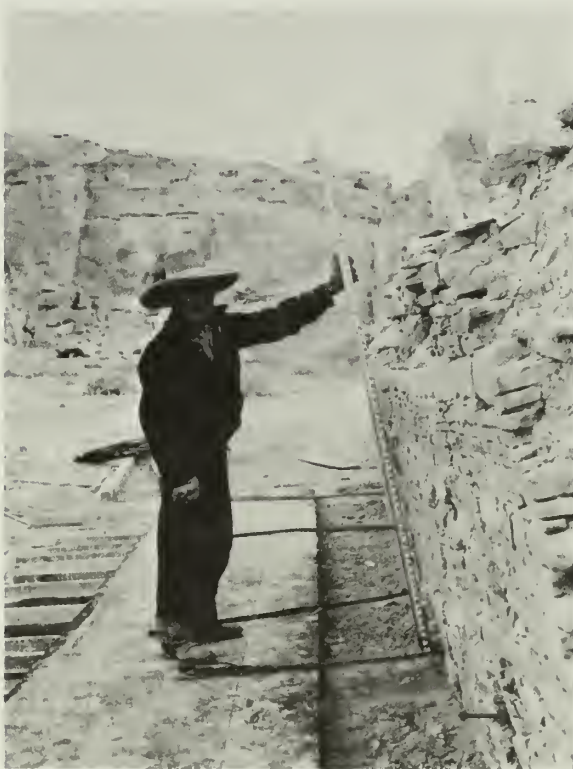
Realignment of distorted, out-of-plumb walls is seldom practicable unless the wall is in otherwise good condition (figs. 33, 34, and 35). If the wall has to be realigned and is in poor condition, it must first be strongly repaired with a soil mortar. Do not repair the wall with cement or stabilized soil mortars. Considerable time, care, and equipment are required to realign a wall of any size. The general requirements are, first, that the wall must be completely formed on both sides and, secondly, that it be thoroughly damp if it is not to be cracked further or distorted in some other directions. The steps taken should include:

FIGURE 33. Beginning realignment. Cables have been placed through the base of the wall to be tied to the jacks. Note bolt, lower right, for holding frame against wall. (Pueblo Bonito, Chaco Canyon National Monument, N. M.)

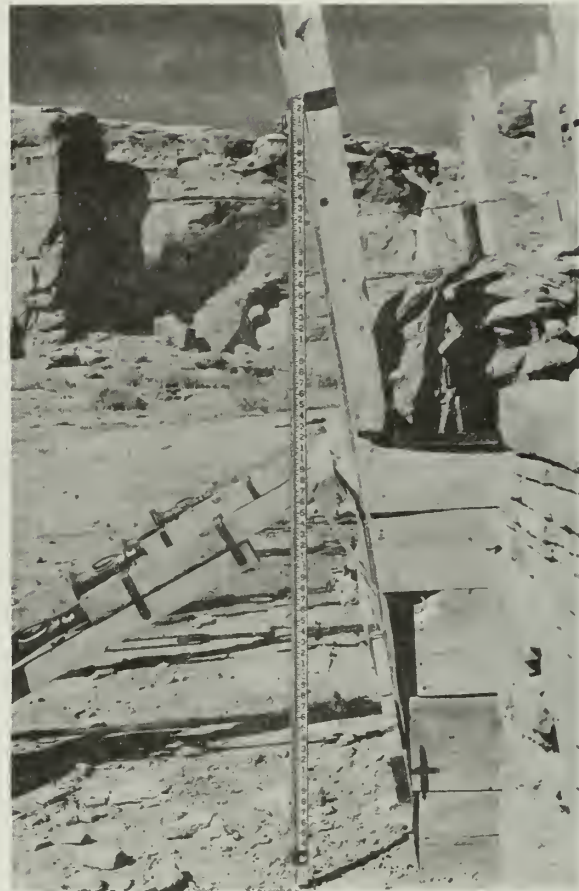
FIGURE 34. Realignment of wall depicted in figure 33. The framework is in place on both sides and is tied together. Frame lined with asphalt paper, space between frame and wall packed with sand. Note that the five screw jacks in sleeves bear against a 4 x 4 timber to distribute pressure.

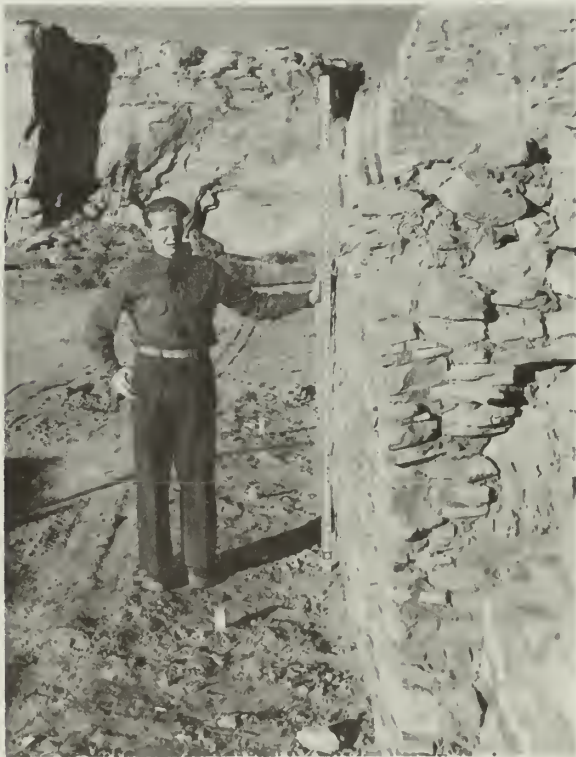
FIGURE 35. The wall depicted in figures 33 and 34 after pressure had been applied for three weeks by means of jacks in sleeves.

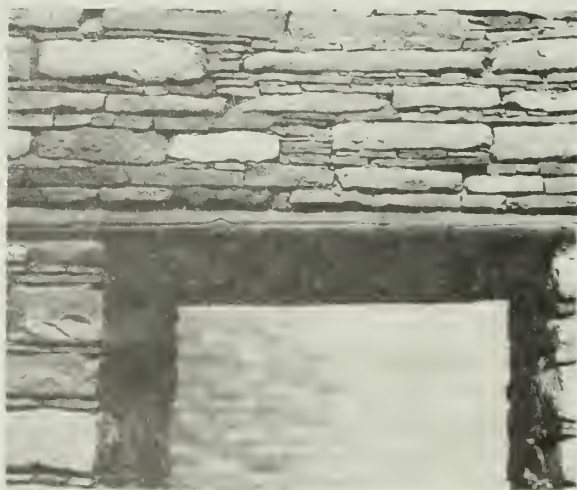
FIGURE 37. The cast concrete lintels have the same appearance as the originals from which they were cast. (Chetro Kettle Ruin, Chaco Canyon National Monument, N. M.)

masonry. The use of cast lintels and poles eliminates many of the above difficulties. They permit the replacement of wood with little disturbance; they provide a strong, rigid and very durable member. Cast lintels take the same surface and texture as the wood from which cast. With a little care they may be stained to faithfully reproduce the original (fig. 37).

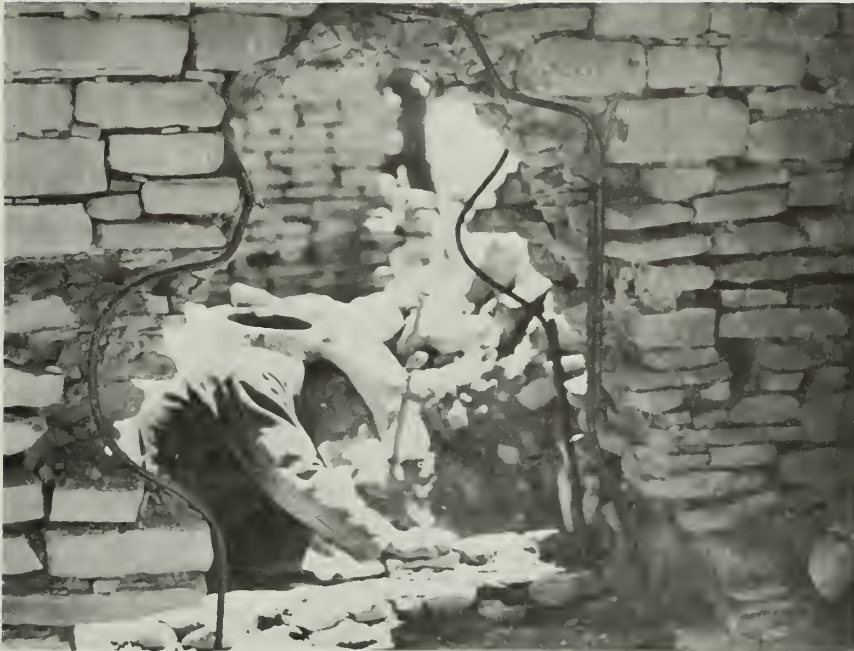
FIGURE 39. Integral members. Starting a reinforced arch section, rods have been bent to fit the contours of the break and are wired in place. The workman is laying the courses across the bottom of the break in concrete mortar to provide a solid base for the reinforced section. Above this level, masonry on the perimeter of the hole will be laid in concrete mortar which will also surround the steel rods. Masonry in the center of the hole will be laid dry or with a minimum of soil mortar; its only function will be to support masonry laid in cement until the latter has set. This dry masonry will then be removed. (Pueblo Alto, Chaco Canyon National Monument, N. M.)

outlines of the break. One piece goes on each side of the wall and just far enough inside the opening to allow a covering face of masonry. The two ends of each piece will rest on the masonry just laid across the bottom of the opening (fig. 39).

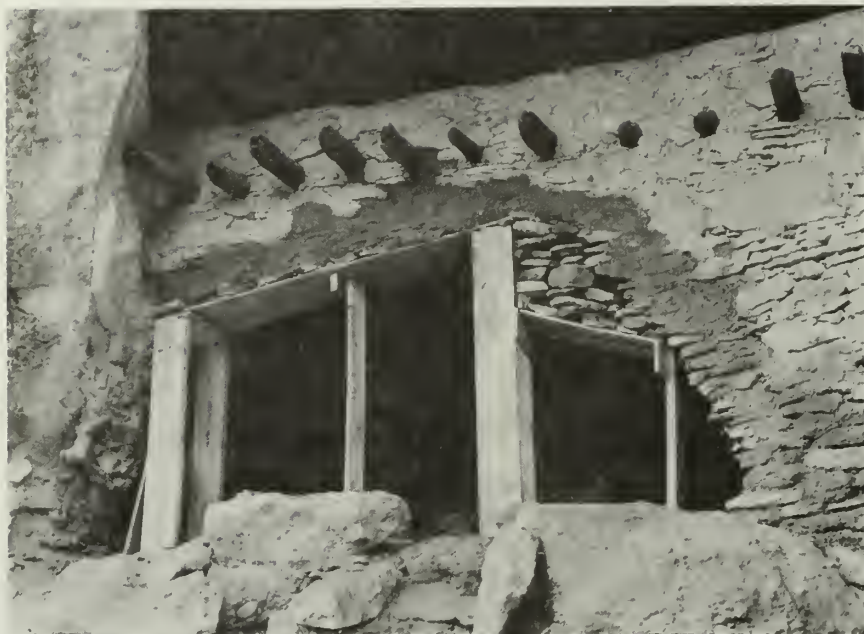
FIGURE 40. Integral member; a large reinforced arch section. The size of the break through the wall precluded filling the center with dry masonry as support, and the timber framework was substituted. The heavily reinforced band is socketed in the cliff wall at the left side, and based on bedrock at the right. The integral member has just been finished and the mortar has not yet dried. After the mortar has set the timber framework, the dry masonry at the right and that on top of the horizontal plank were removed. The large hole with its original outline remained. (Gila Cliff Dwellings National Monument, N. M)

tected from further breakdown by the reinforced band (fig. 40).

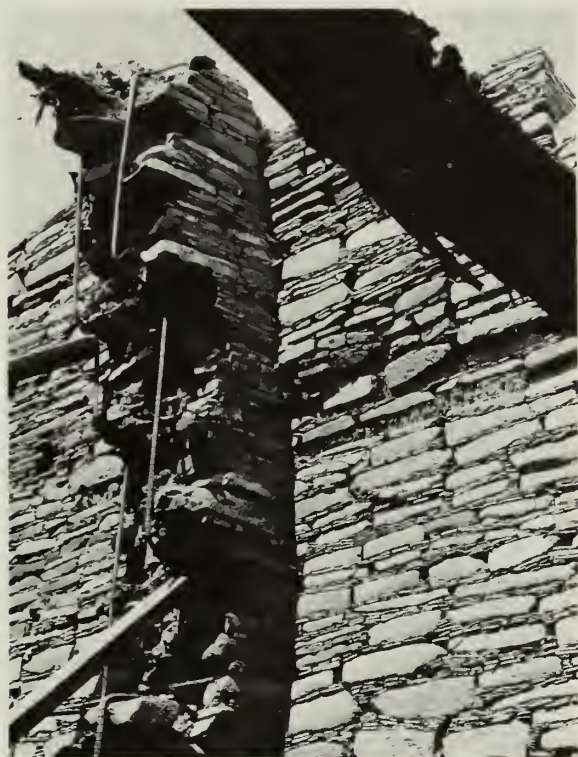
FIGURE 41. Integral members; steel in place for a narrow vertical section. The steel must be tied in securely to the cross wall at the top to provide support for the overhanging area. Some support will be required for the vertical strip of masonry as it is being laid, and until the concrete mortar has set. (Chetro Kettle Ruin, Chaco Canyon National Monument.)

The principal application of these members is to tie together sections of separated and out-of-plumb walls, to reinforce walls against which there is pressure of retained fill, to re-lay overhanging and precarious sections, and to provide support over horizontal logs (figs. 41, 42, and 43). Since conditions and structures vary so greatly, it is difficult to anticipate all possible applications. In general, the requirements are:

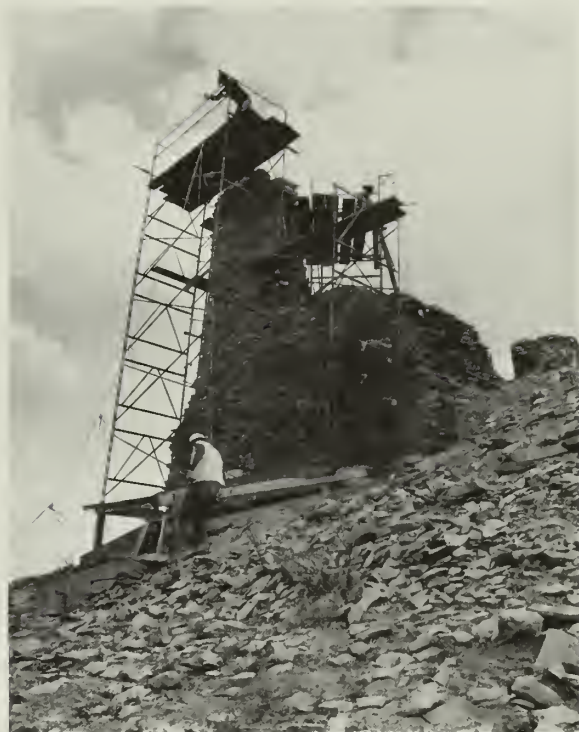
FIGURE 42. Reinforced integral members are important in the stabilization of spirelike structures such as this at the Tower Kiva, Kin Ya-a Ruin, Chaco Canyon National Monument, N. M. Considerable strength must be added without serious or objectionable alterations of the original profile.

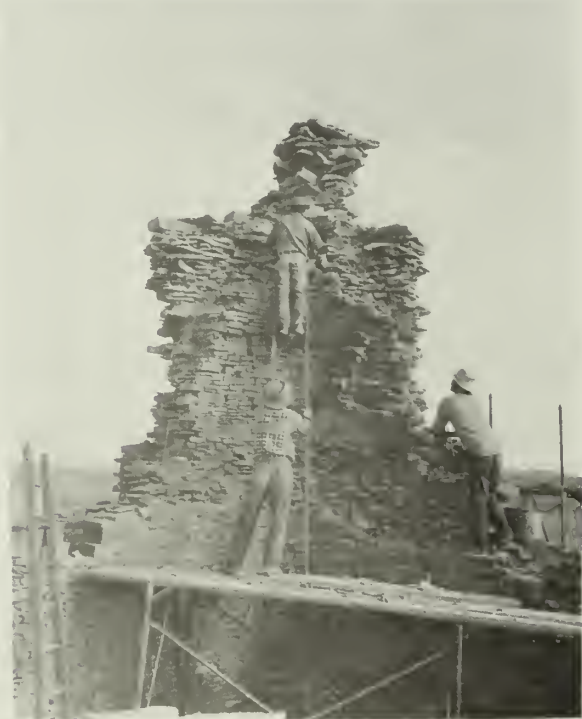
FIGURE 43. The placement of reinforcing in the third story portion of the structure shown in figure 42. The purpose is to reinforce heavily the vertical capping which will be placed up exposed ends of the wall to prevent further erosion, and to tie this part of the wall together.

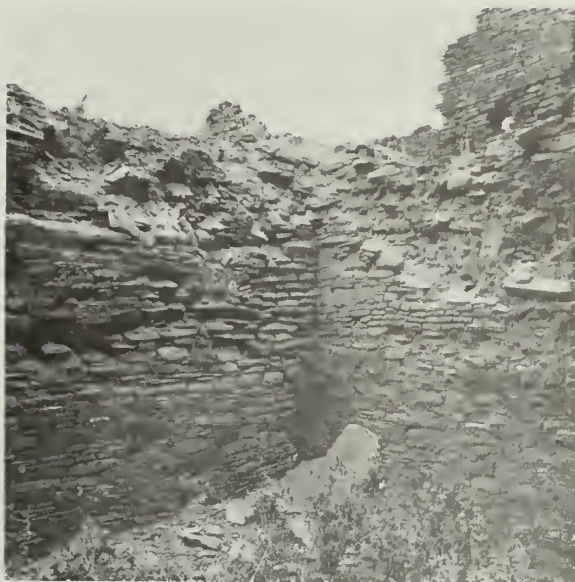
FIGURE 44. In many cases such as that depicted above it will be difficult to draw a distinction between general wall repairs and capping. This wall will have to be carried up to the level of the outside fill to prevent further washing over the top. Whatever type of mortar is used for such wall repairs, the top courses must be set in a cement mortar to provide as durable and waterproof a cap as possible. (Pueblo del Arroyo, Chaco Canyon National Monument, N.M.)

1. In capping of any wall, sufficient loose and decayed material must be removed to insure a

good bond with sound masonry (of stone, brick or adobe) below (figs. 44 and 45). Where regular units are employed in coursed walls, a sound, even surface must be reached or built up on which to place the flashing. In most cases, sufficient courses should be removed to provide the desired depth of capping without the addition of new units. Where the upper levels of a patch are to form a cap, new stone or other units must be employed (fig. 46).

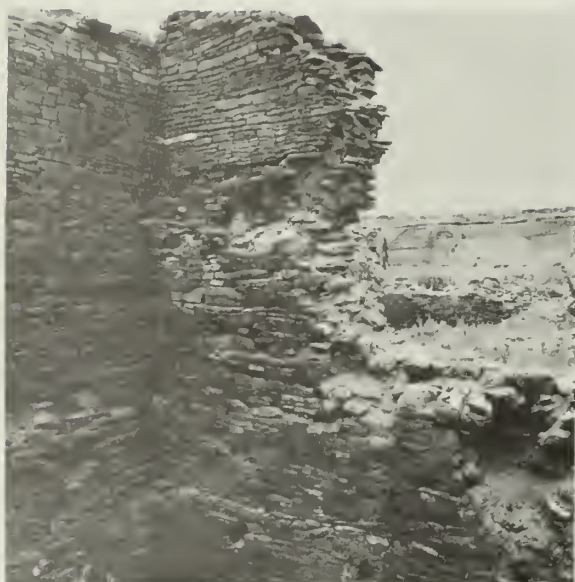
FIGURE 45. Patching of this hole at Pueblo del Arroyo will be combined with a short section of horizontal capping plus vertical capping for the exposed and weathered vertical rise of wall.

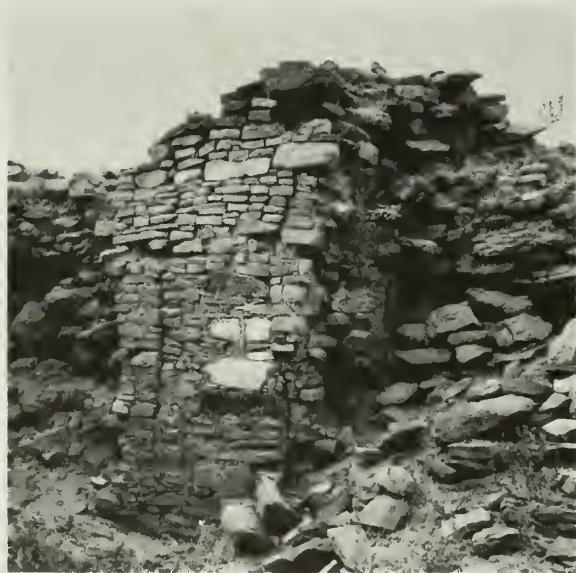
FIGURE 46. A good deal of repair masonry must be laid to fill breaks and support undercut areas in this wall at Pueblo del Arroyo. Some support must also be provided for the embedded timbers. Soil or masonry cement mortars may be used for the major part of this work. The upper courses however must be laid in concrete mortar as capping to halt further washing from the top. In this example, damage was started by surface water from adjacent, unexcavated fill and every effort should be made to prevent erosion.

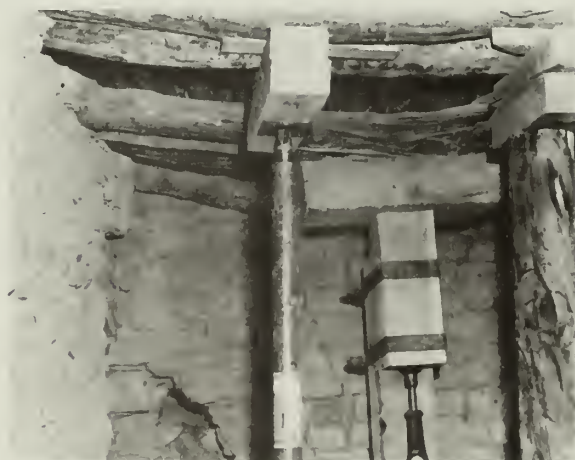
FIGURE 47. Temporary support of cracked and broken roof beams by means of jacks and timber props. Approximately 6 feet of overburden lay on this ceiling. The temporary supports were in place for several years before the overburden could be removed and a protective roofing constructed. (East Ruin, Aztec Ruins National Monument, N.M.)

From this and similar experience with difficult roofs evolved the coverings designed for and installed over 14 prehistoric ceilings in the East Ruin of Aztec during 1957 (figs. 47 and 48). These were in an unexcavated site where the only previous protective measure taken was the temporary bracing of cracked and broken timbers.

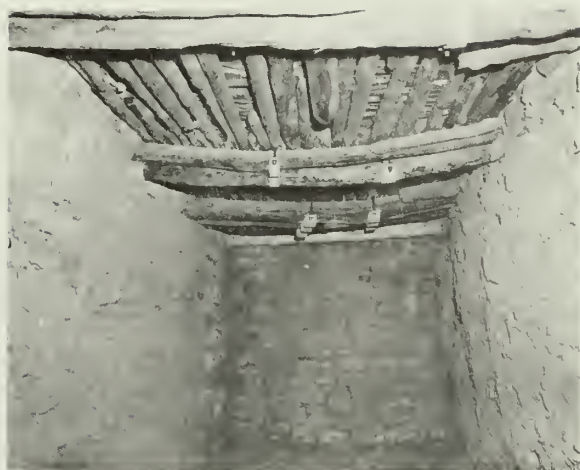
FIGURE 48. The ceiling shown in figure 47 after removal of the overburden and construction of a slab roof which protected the ceiling and permitted support of broken beams. The bolts are fastened in the slab above, and were taken up enough to transfer most of the weight from the old ceiling beams to the new roof.

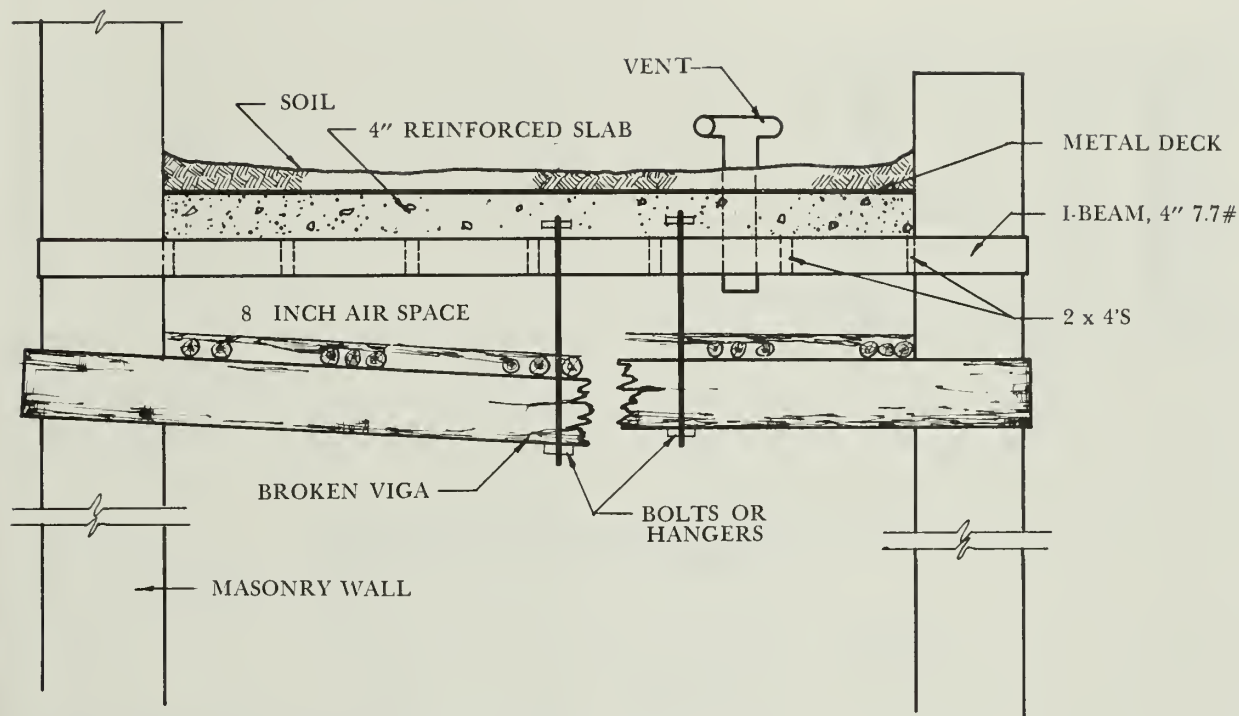
FIGURE 49. Typical roof covering and support employed at Aztec Ruins National Monument.

The general design of slab-type roofings are shown in figures 49, 50, and 51. No part of the new roofing may be supported by the aboriginal ceiling either during or after construction. This requires that the construction be self-supporting during the time that the concrete is being poured. Ordinarily, concrete forms for floors and decks are supported during pouring by vertical members from below, and the supports and forms are removed after the concrete has set. However, this is not possible in the placement of slabs over existing roofs where the space between the new slab and the old ceiling is usually less than a foot, and there is no means of access between the two.

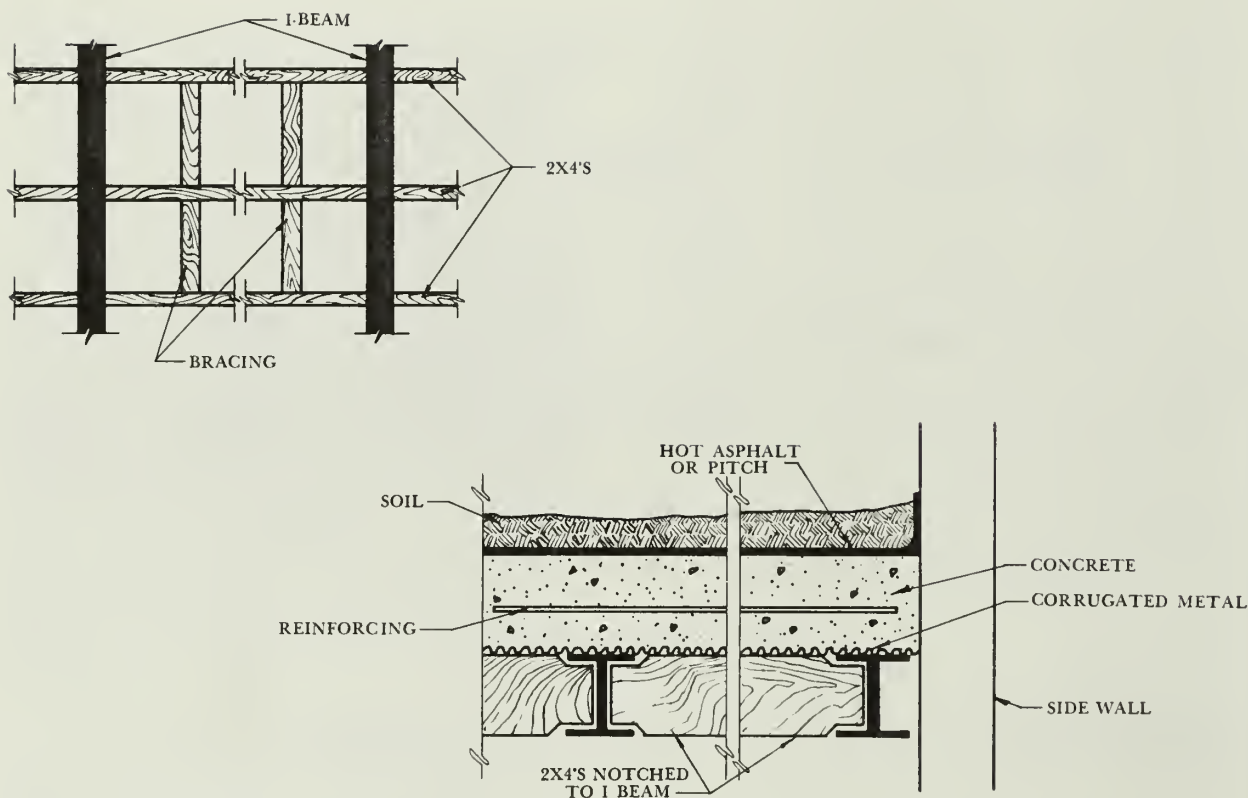
FIGURE 50. Details of roof supports (in section) at Aztec Ruins National Monument.

If the prehistoric ceiling has been subjected to heavy overburden or has been wet, it will probably require support from the protective slab, a provision which must be made when the slab is first being laid out. Support may consist of bolts which extend up through the center of broken or cracked beams or by pairs of bolts, one on each side of the beam to support a hanger under the beam. Bolts should have ample threads (threaded rod is preferable to standard bolts) so that they can be taken up sufficiently to support most

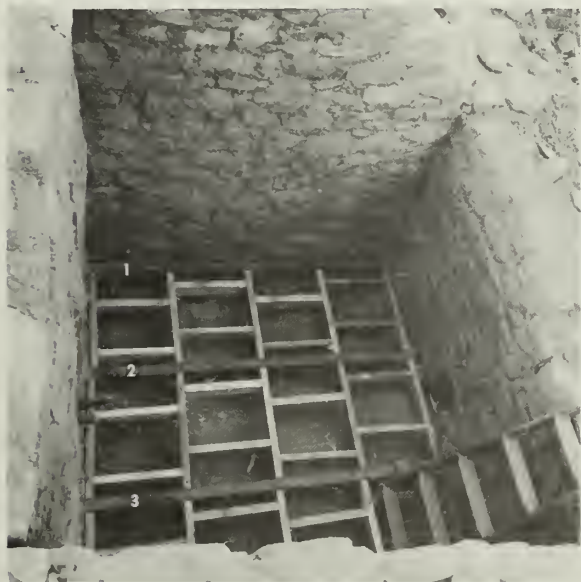
FIGURE 51. Construction of a slab covering. The numbered members are I-beams run through heavy masonry walls. The longitudinal members are 2 x 4's inset in the I-beams as purlins. Corrugated metal decking will be nailed to the wood as a base for a concrete slab. A covered vent will be provided through the concrete. Drainage will be provided by tile line through the wall at the right. (East Ruin, Aztec Ruins National Monument, N.M.)

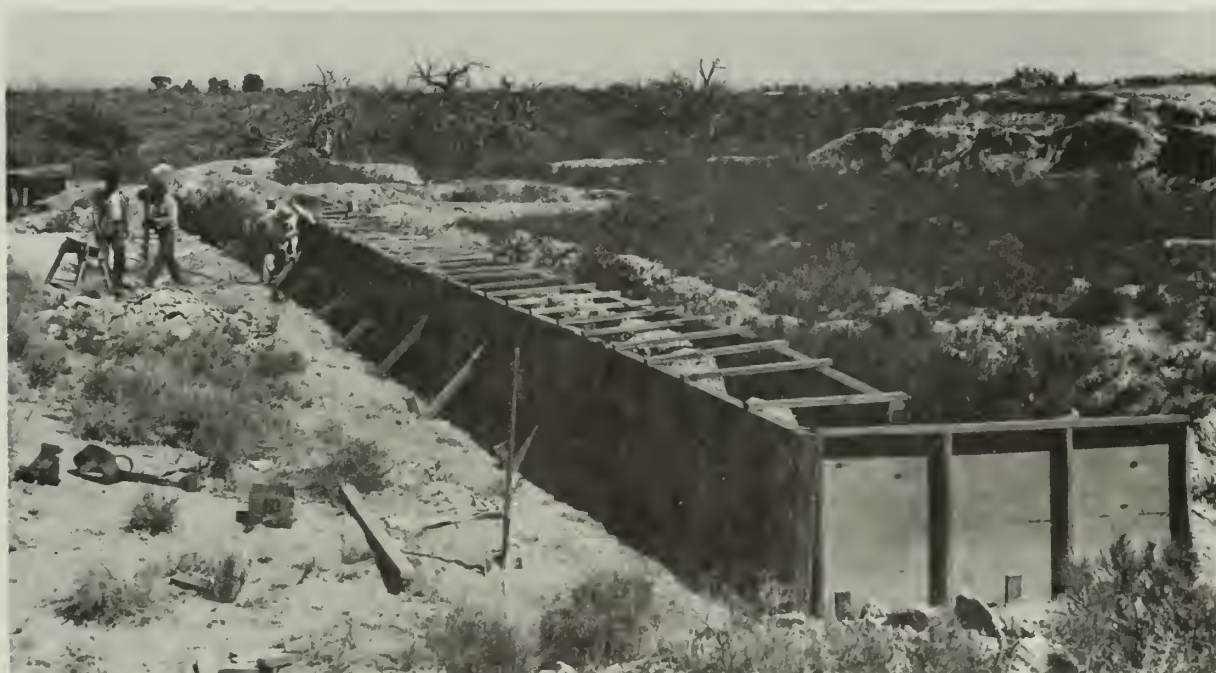
FIGURE 52. Placement of forms for stabilization of a wall with caliche-based soil cement. The forms are braced at the sides and tied at the top. (Compound B, Casa Grande Ruins National Monument, Ariz.)

In all caliche walls, i.e., those of high lime soil content encountered in Compound B, weathering had greatly reduced the original width above the surface of the ground. Both sides of the wall were trenched until the original width was reached at depths up to 18 inches. Forms of heavy plywood, reinforced with 2x4's, were then placed at the edge of the wall rising vertically from the uneroded subsurface line (fig. 52). The space between the remaining wall surface and the forms was wide enough so that the caliche-cement would be sufficiently thick to stand by itself, and not be dependent on the aboriginal wall for support. General requirements for placing concrete forms were followed; they were oiled, and securely braced.

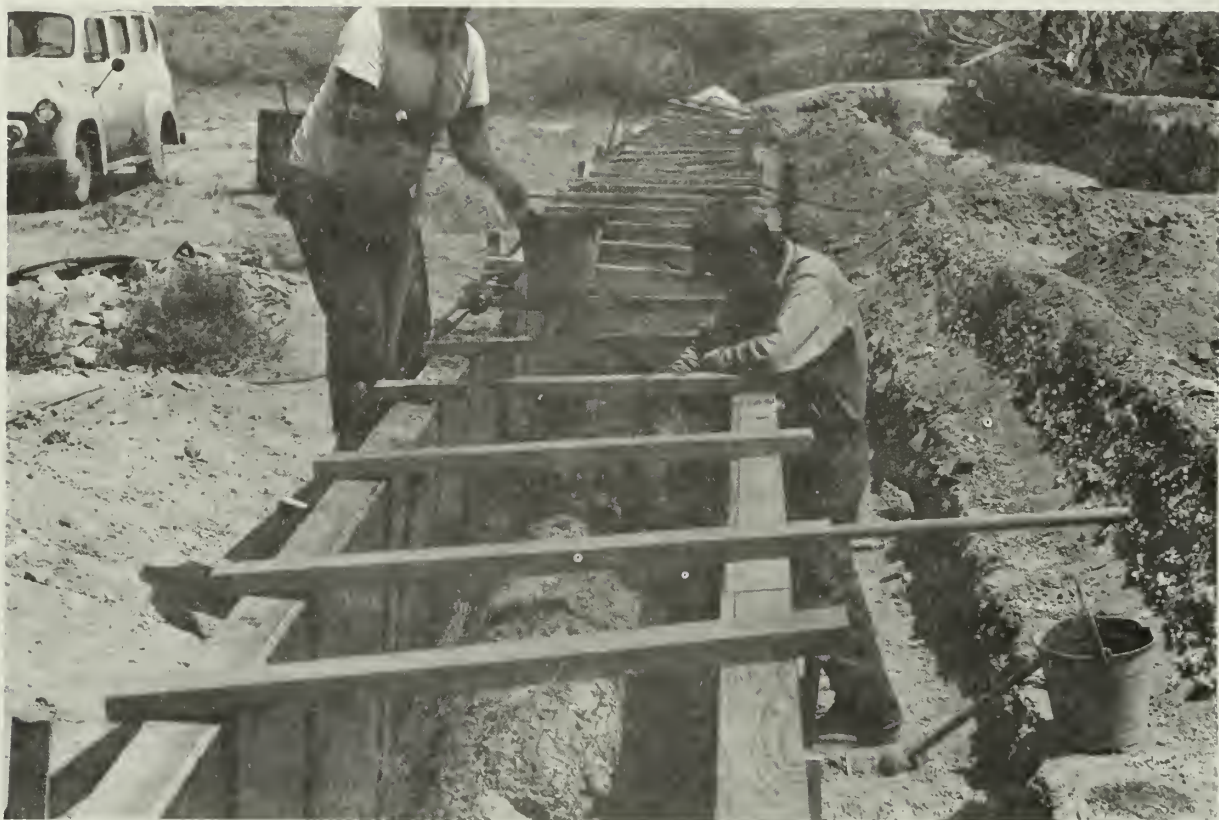
Since long experience at Casa Grande has demonstrated that it is impossible to make a thin covering of either cement, stucco, or soil-cement which will adhere to the original wall or will not crack and remain waterproof, a slightly different approach has been tried recently on exposed walls of Compound B.

FIGURE 53. The start of placing caliche-cement mix over the wall depicted in figure 52. Note that the forms follow the irregular line of the wall.

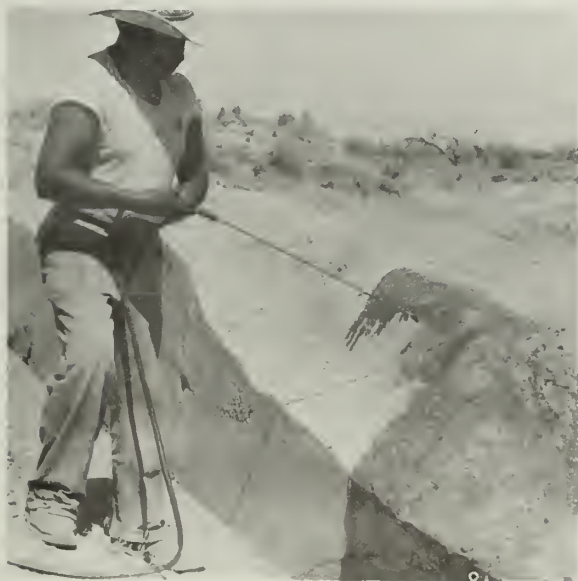
FIGURE 54. The application of a silicone water repellent. It is applied in a coarse stream, sufficient to produce a rundown of from 6 to 8 inches. (Casa Grande Ruins National Monument, Ariz.)
